RE-CERTIFICATION PROGRAM

Inspection Guidelines for Wheels and Rims

Visual and Magnetic
Particle Inspection Handbook

RIMEX
Building better wheels

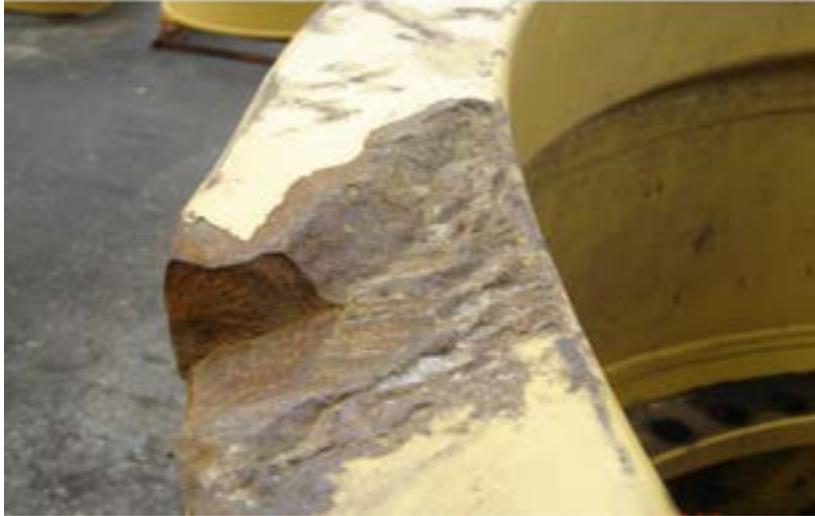
Under normal conditions, the face of the gutter will have few signs of wear. If damaged does occur, it will be from mechanical, external impacts or damage from the spacer band (picture 3.21 - see next page). Each incident needs to be assessed individually. Magnetic Particle inspection is recommended at specific sites where the inspector observes an area of concern. If the structural integrity or roundness is ever in question, the gutter section should be replaced.

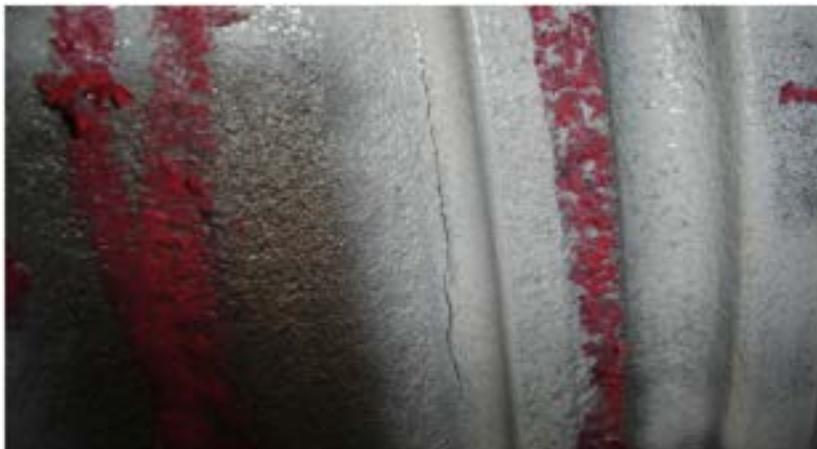
3.31

The lock ring and o-ring groove should be carefully reviewed 360° around the rim. Any visible indications, mechanical damage, or excessive wear needs to be assessed. The o-ring groove is a very critical area as any mechanical damage or excessive corrosion can cause air loss (picture 3.31).

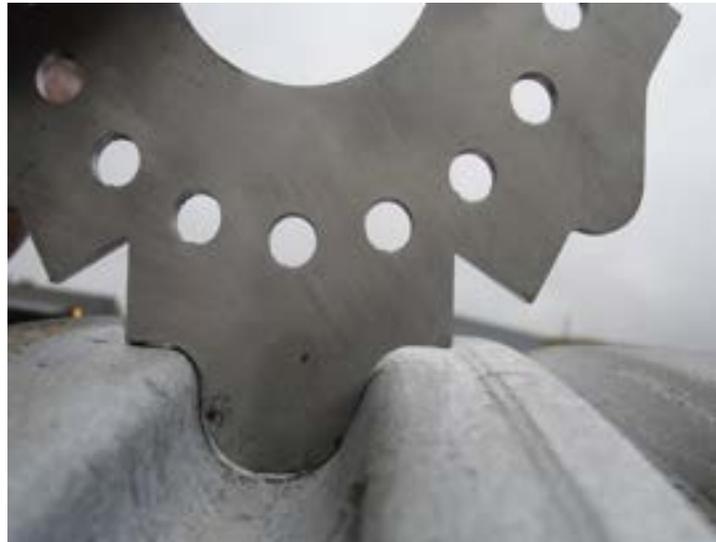
3.33

The best way to review the condition of the grooves is with a Rimex Gauge (part number 782 000 0025). A rim in excellent condition will show minimal gap between the gauge and the rim. (Picture 3.32) In the picture (3.33), the depth of the area eroded has exceeded 2 mm, resulting in a failure of the section. Excessive mechanical damage, which cannot be smoothed out by grinding or sanding of the surface can also result in a failure of the section. In the case where the integrity of the grooves have been compromised, the gutter section must be replaced. Typically, after years of service under normal operating conditions, a large diameter gutter section (ie.63") will fail the gauge exam before you will see a crack in the groove.

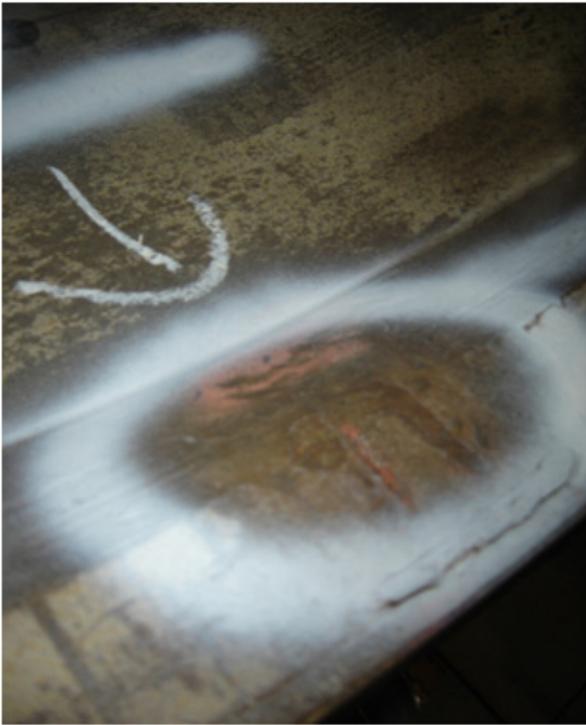
3.41

Spun Gutter- Removed Valve Protector

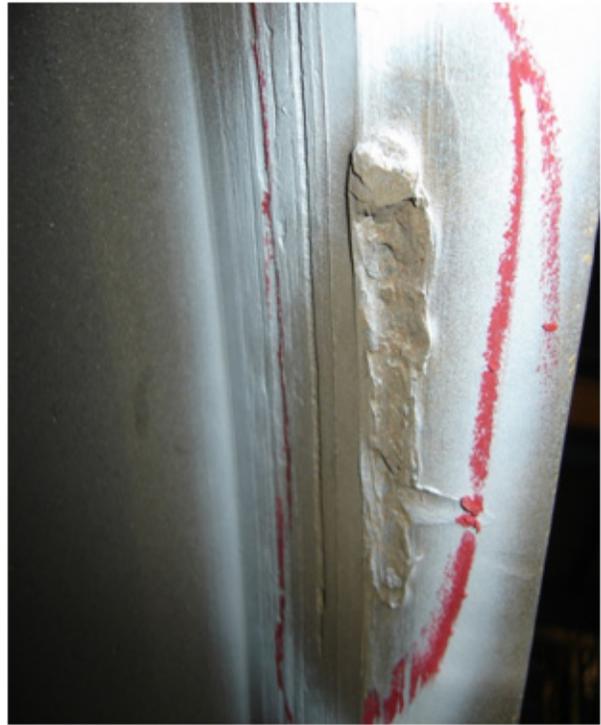
3.42

A visual inspection of these areas should indicate no signs of mechanical damage, and or scarring to the gutter ID surface. Usually, damage occurs to this region of the gutter when the rim has not been properly secured, allowing the rim to rotate around the hub. This spinning of the rim can damage the mounting taper (picture 3.42) and/or the valve protector. In extreme cases the valve hardware can also be damaged leaving broken brass in the valve hole (picture 3.41). A mild case of this spinning may only result in a damaged valve locator, which can be replaced. When the mounting taper has been damaged, 95% of the time a new gutter is required.

Spun Gutter - Damage to Taper (Mount Taper)

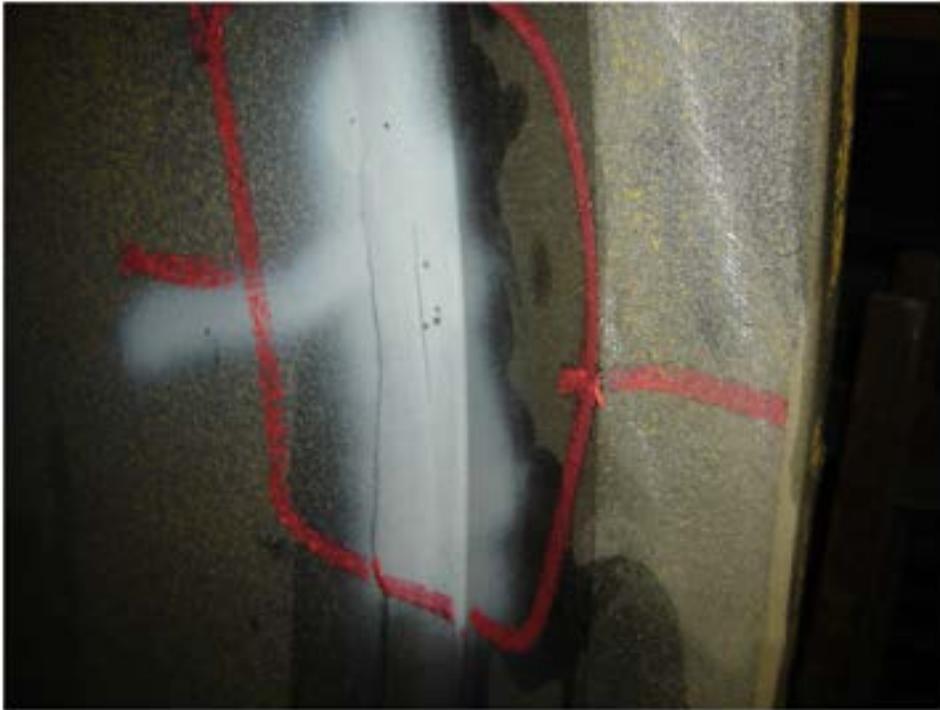
3.51

The gutter section is secured to the rim (center band) at the gutter circumference weld (GCW). If a GCW is going to crack, it will more likely occur on a rim than a wheel. This is due to the mounting taper on a rim; more stress is placed on the gutter section. For the visual inspection, cracking and excessive corrosion should be looked for. If a rim is mounted to a tire without an anti-corrosive agent such as Rimexcel, extreme corrosion and injury to the metal can occur. After time, if not corrected, this may lead to a crack in the GCW (picture 3.51) or o-ring groove.

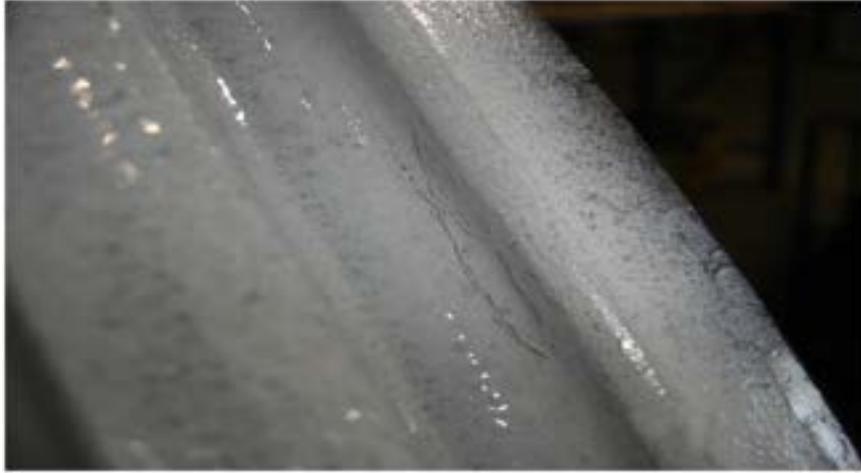
3.61

Gutter: Superficial indication in the lock-ring groove - OK for service.

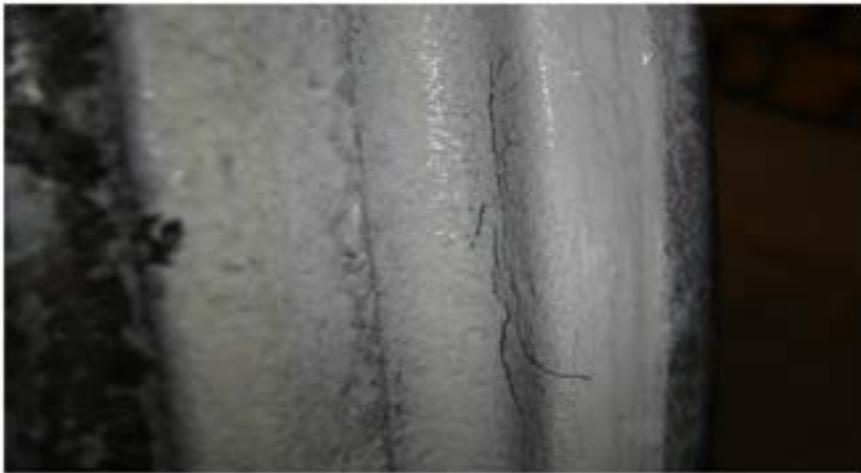
3.62

Gutter: Indication has developed over the lip, section has failed and should be replaced. If minor indications stay under the crest of the lip (as seen in the previous picture), the gutter is OK for service.

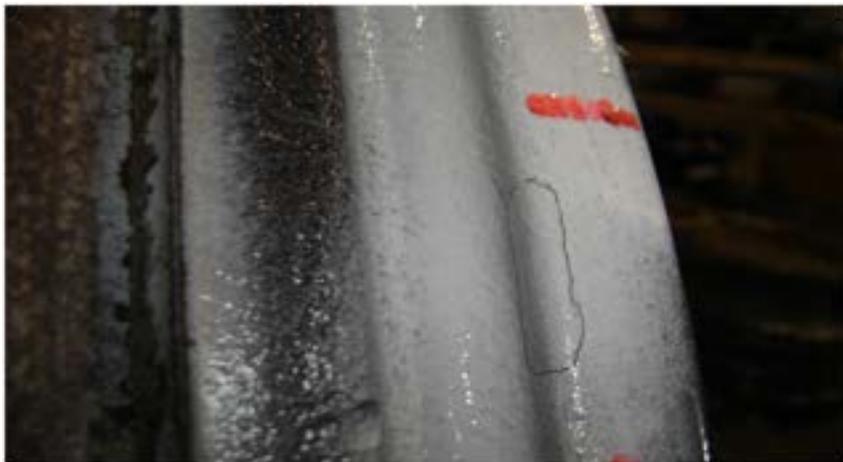
3.63

Gutter: Oval crack pattern complete in the gutter lip = failed section

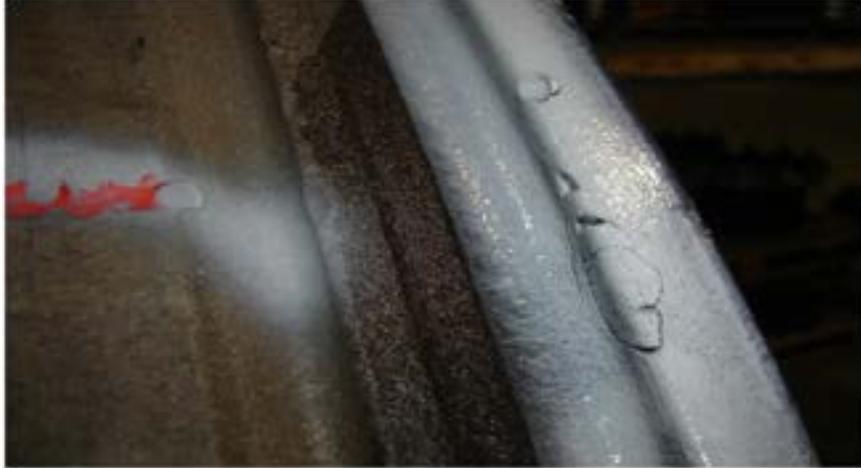
3.64

Gutter: Final stage - oval crack pattern breaking apart = failed section

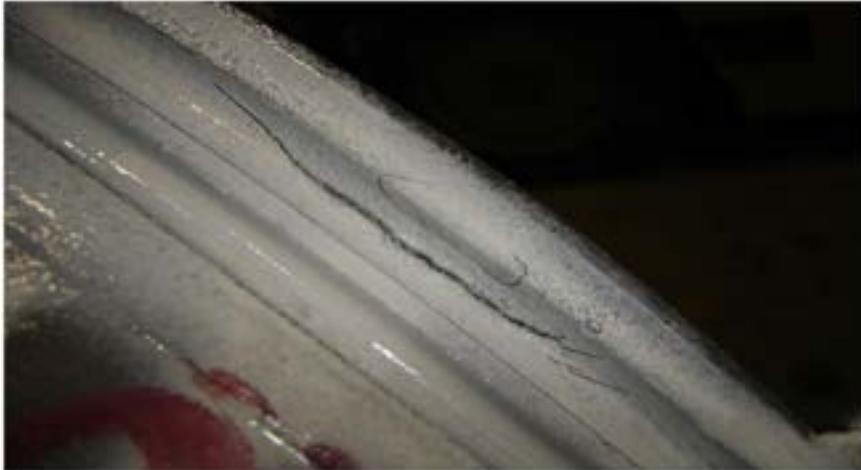
3.65

Gutter: Crack deep within lock ring groove. This is not a minor indication but a long and deep crack. LRG is separating from the applied force. Catastrophic failure is imminent - failed section.

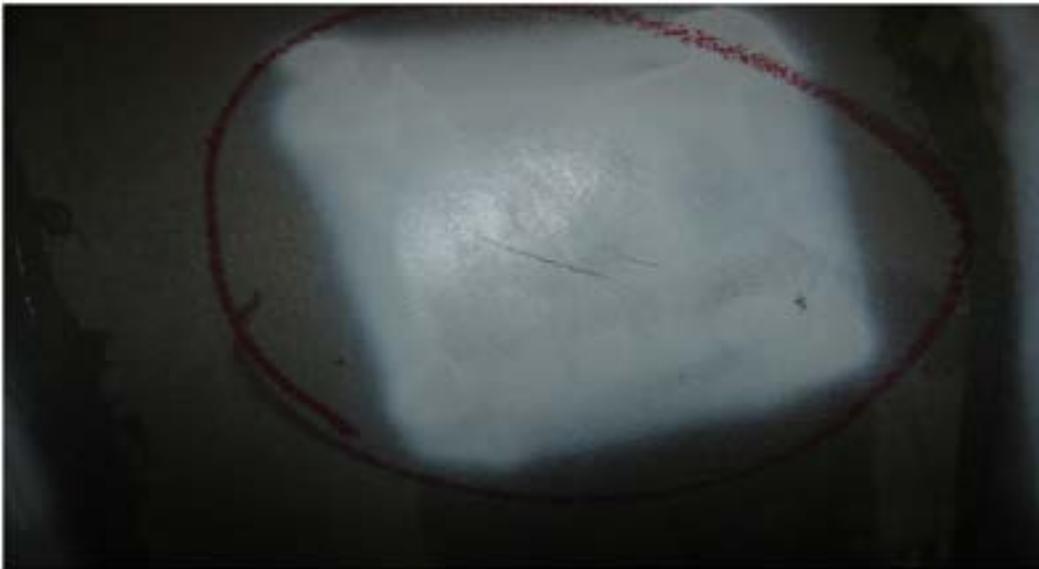
The center band is the middle section of a rim. It is secured to the rim at the forward end at the GCW and at the rear position by the back circumference weld (BCW). This is the standard design for a Rimex rim, while other rim manufacturers will have additional center band material and welds. For inspection purposes, the OD of the center band is located within the tire. Overall, corrosion of the metal is the most common condition found when improper maintenance has been done. The result of this condition will be discussed in the Valve/De-Fuzer section (6.0). Since this is solid piece of metal, we do not MP inspect the center band section. Only the welds and valve holes are MP inspected. Rarely do we see cracks in the center band section. 4.01 is an example of a crack in the center of the CB, this is commonly seen from a valve hole that had been filled.

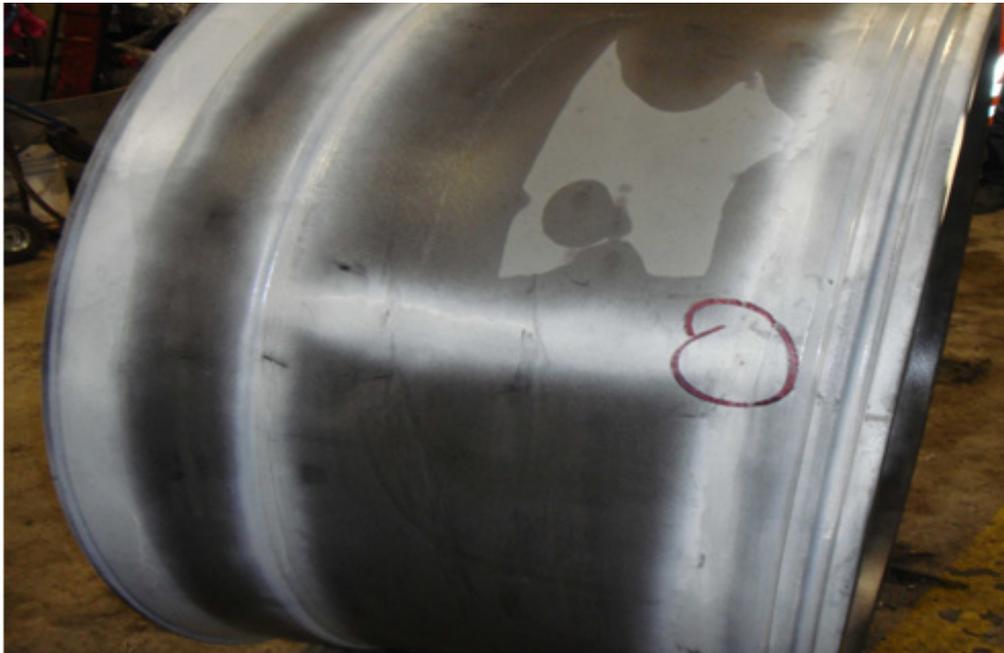
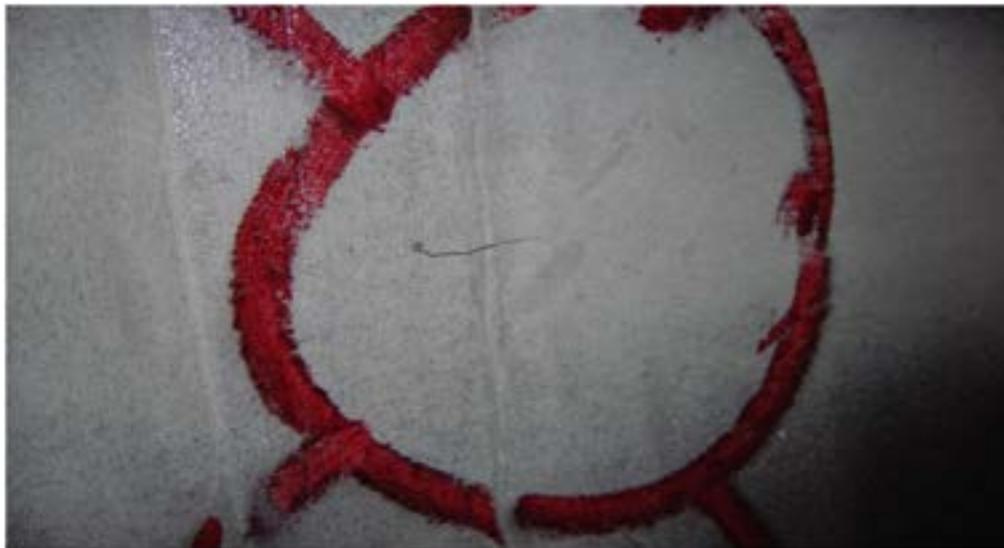
The Butt Weld is seen as the horizontal weld which completes/secure the individual section. For Rimex products, the center band butt weld is the only one which is visible. Issues with this weld are uncommon, but occasionally a crack will occur so it should be included in the MP Inspection. An example of such a crack at the junction point between the GCW and Butt Weld of the center band can be seen in picture 5.01 and 5.02.

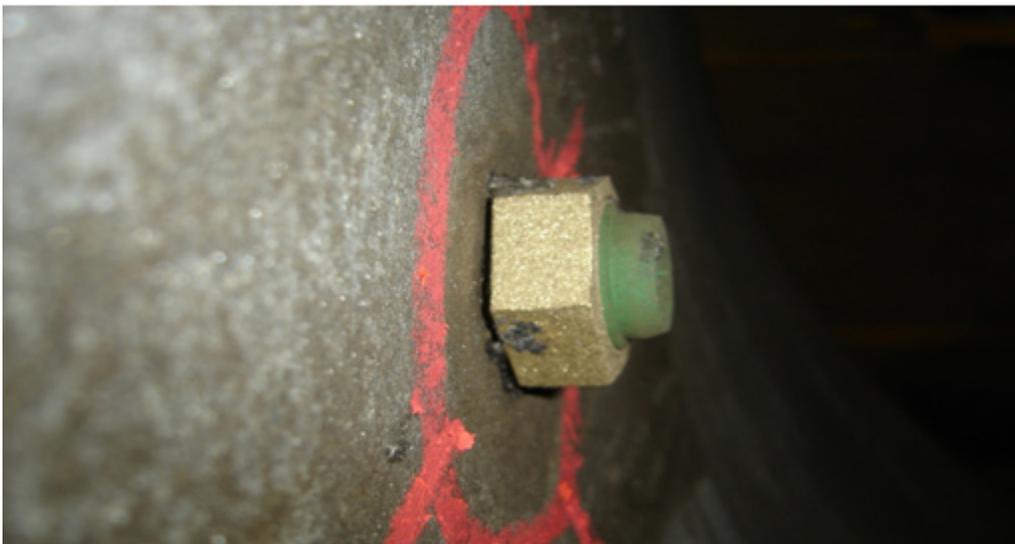
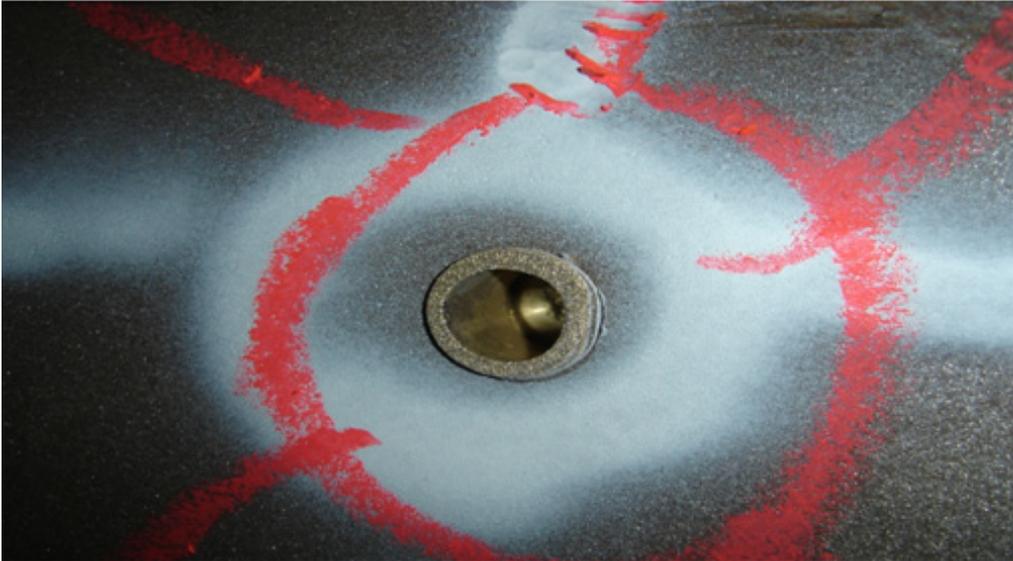
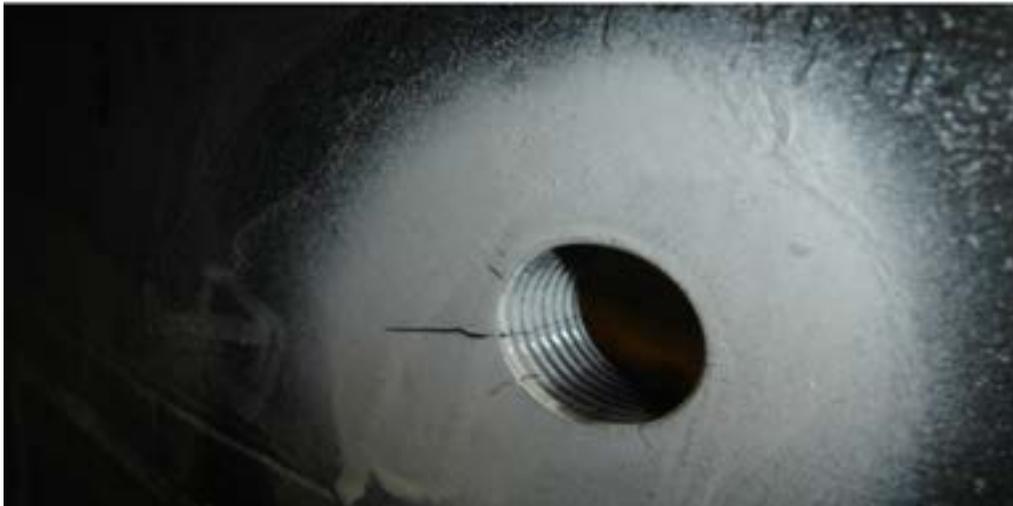
All Rimex valve and DeFuzer holes are threaded to NPT standard ANSI / ASME B1.20.1 - 1983 (R 1992). The standard NPT hole sizes are a 1/2" for the valve system and a 3/4" for the De-Fuzer Valve. This critical area must be properly maintained. To conduct a proper inspection, all valve hardware should be removed. If the brass is damaged within the hole, it must be removed and the threads checked. If no anti corrosive agent is used or improperly administered, the integrity of the metal can be compromised. It is sometimes seen in extreme cold climate where corrosion can eat through at the valve holes. This results in air loss and can create a center band section failure (6.01). In addition, NPT valve holes should never be completely threaded through the centre band (picture 6.02, 6.03) as this may lead to cracking and/or valve sealing issues (picture 6.02 - 6.04).

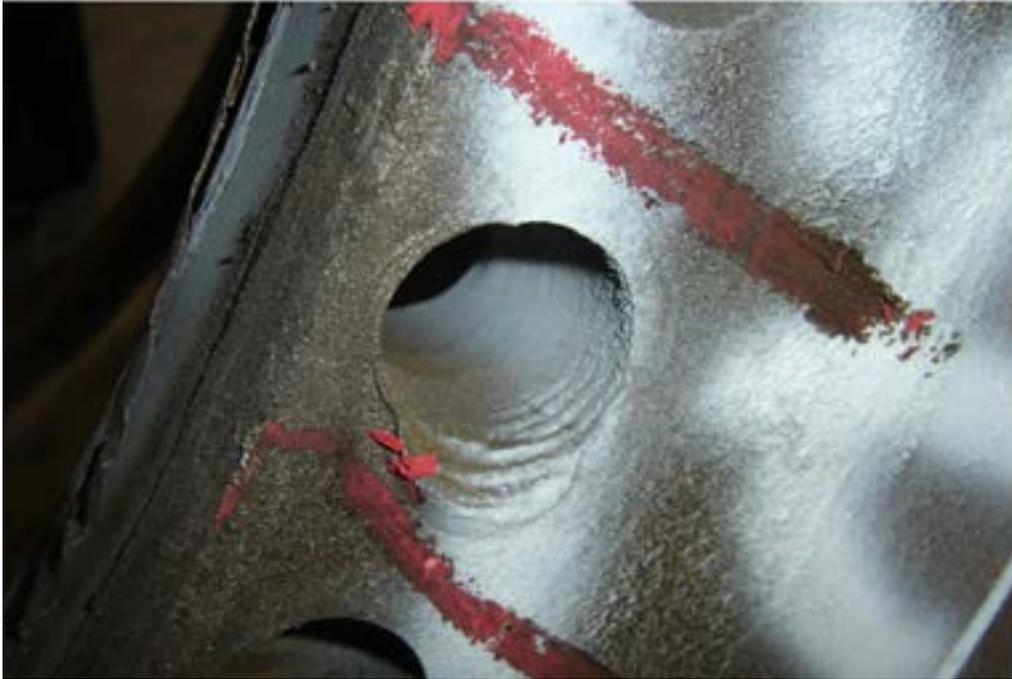
7.01

The mounting disc is used to bolt the wheel to the hub. Failure to properly mount the disc to the hub is the most common reason for damage. The result is the irregular shaping of the OD of the stud holes. Most of the time, only certain sections of the disc will be affected. In more severe cases, threads from the studs may be embedded into the stud holes (picture 7.01). Replacement of the disc section is usually required.

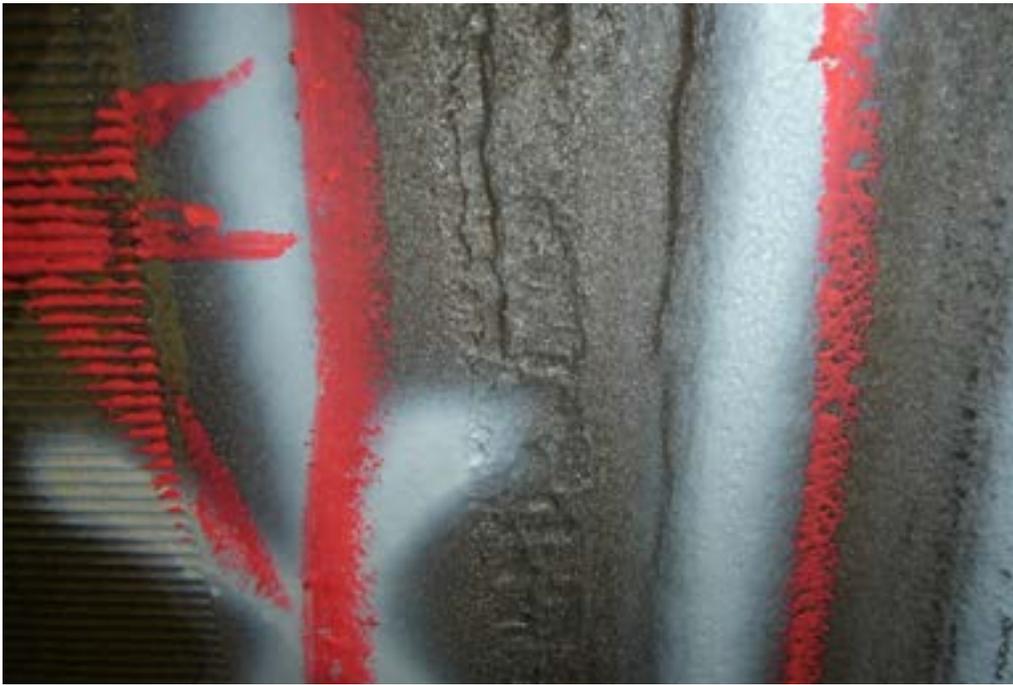
8.21

The back tire bead taper is the area in which the tire bead contacts the rim. If the tire slips on the rim, a 360 wear mark will develop on this section of the back. The tire bead with time will erode the metal and cause a change in the contact surface. This will eventually decrease the performance of the tire and rim. If a 360° groove around the BT has been observed, the maximum allowance of the change to the surface of the BT is 2 mm. Any measurement taken beyond the 2 mm, at any point within the erosion area, should result in a failed back section.

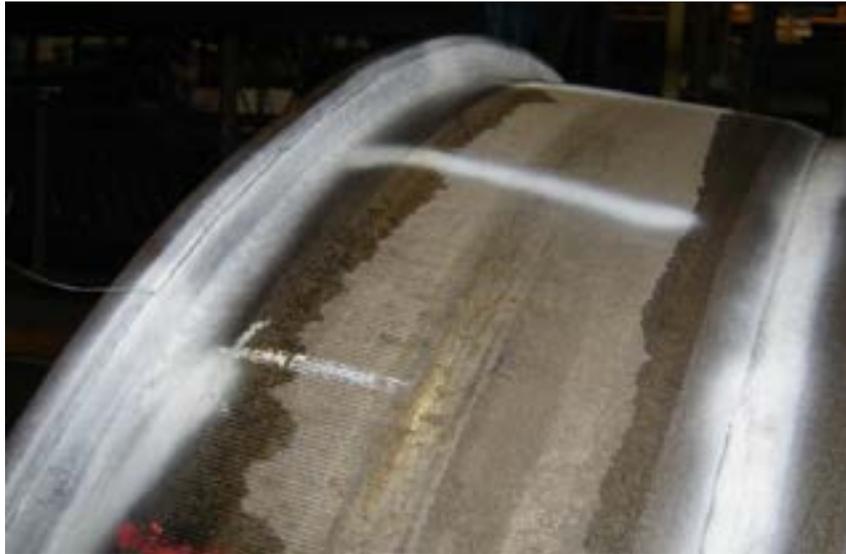
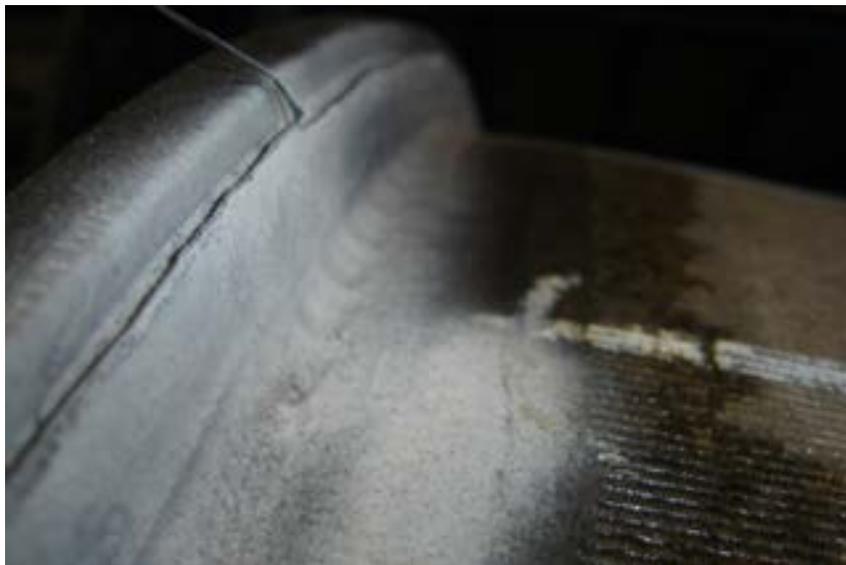
The MES/Standard design has the flange and back lip securing at approximately a ninety degree angle. This design applies a significant amount of force to the lip and flange. Over time, the back lip will compress and fold downward. In addition, under inflation or material within the BL and flange can create extreme galling (metal to metal wear). This wear will affect the performance of the rim to secure the tire. When visually inspecting the rim, one needs to assess the amount of wear and compression to the back lip. It is critical to understand that cracks unseen to visual inspection, may be present. If the compression or galling within the lip itself is greater than 2 mm, the back section should be replaced (8.321 + 8.322).

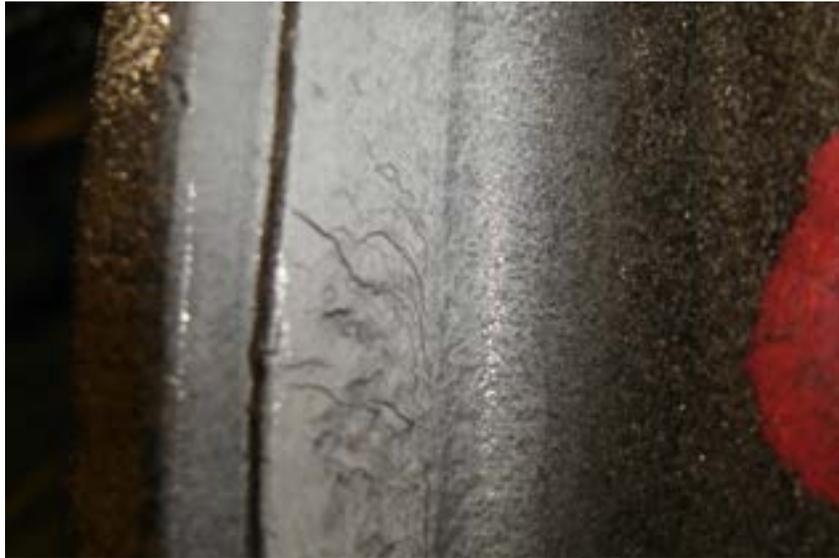
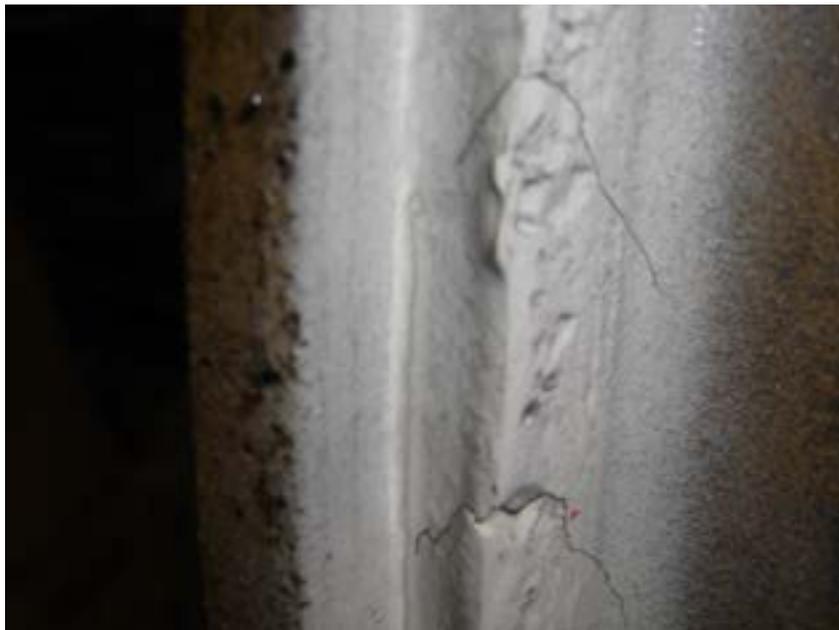
8.323 + 8.324 are examples of a failed back lip section from cracking, only visible by MPI inspection.

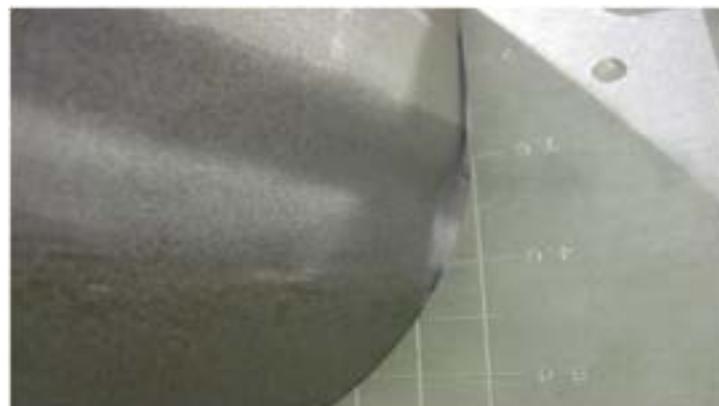
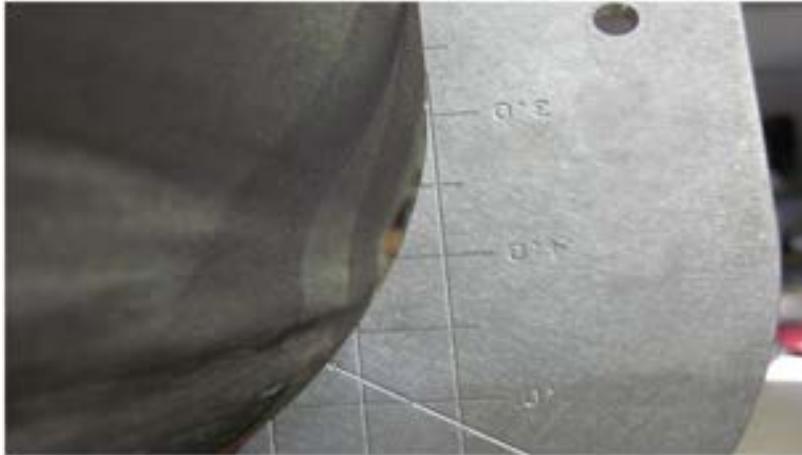
Next is the level of wear to the OD of the SR where contact is made with the tire. The outer diameter (OD) of the SR contacts the tire and holds its bead while inflated (picture 9.13). With use, the tire will wear a 360 mark along the OD of the side ring (picture 9.14, 9.15). With time the metal will erode and loose its ability to secure the tire. The maximum allotment for erosion to the OD of the side ring is 2 mm.

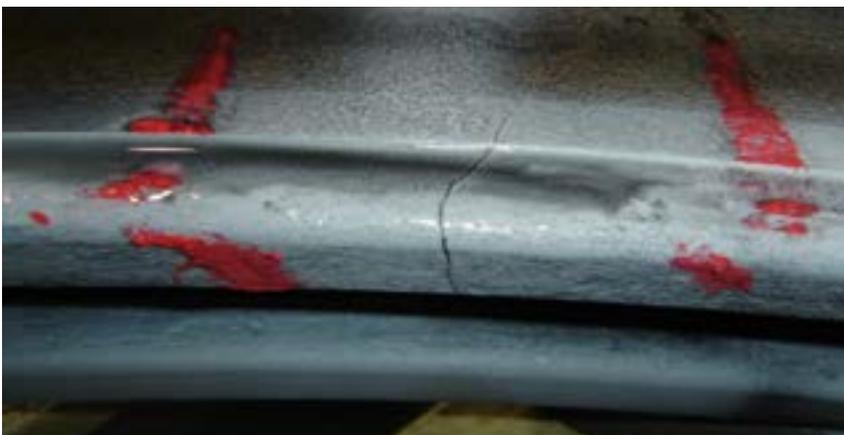
9.16

If the side ring passed the visual inspection, a MP inspection of the ID should be conducted. This step will insure no cracks are present. After blasting (shot peened), spray the contrast paint to the ID side only. Allow to dry, then magnetize the metal while applying the particle solution. Any cracks present will be observed (picture 9.16). If no cracks are found, side ring should be painted and returned to service.

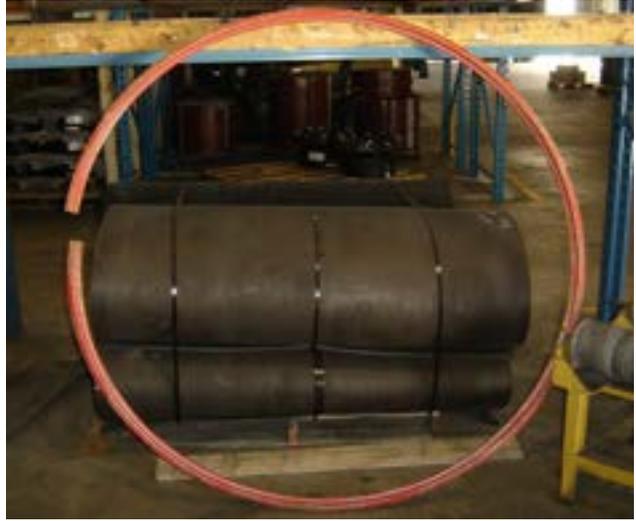
9.33

The Lock Ring is the final part added to secure the Rim/Wheel assembly, holding the assembly together. To secure all the components and minimize the friction between parts of the tire assembly, the lock ring must be elastic to expand then contract into place within the LRG of the gutter section. A new lock ring in will have an overlap of 3 to 4 inches (57" & 63") (picture 9.32) between its tips before mounting. With time, the lock ring will lose its ability to hold its original form. When inspecting a lock ring, the distance between the ends of it and the overall condition of the taper area must be reviewed. When the LR is not installed, the ends of the tips should overlap (picture 9.32). Once a lock ring loses its ability to bounce back to its origin form, distance between the tips will widen and the LR will no longer be usable (picture 9.33).

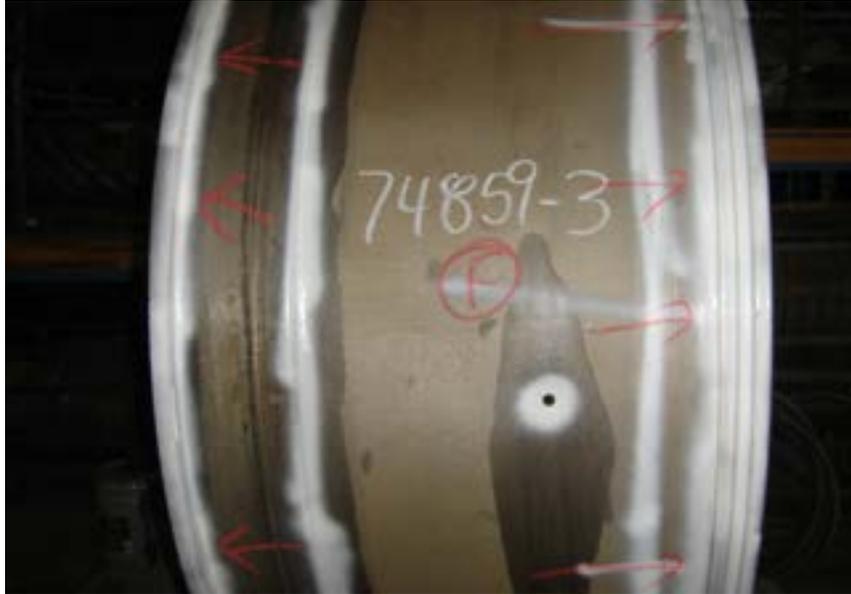
10.01

Example of a two sections failed inspection.
